NUMBER: 08-033-15

DATE: March 31, 2015

Flash: RE2 RE3 RE4 RE6 RE7 RB4 RB5 RB6 RB4 Radio Enhancements

This bulletin involves updating the radio control head software and navigation if equipped.

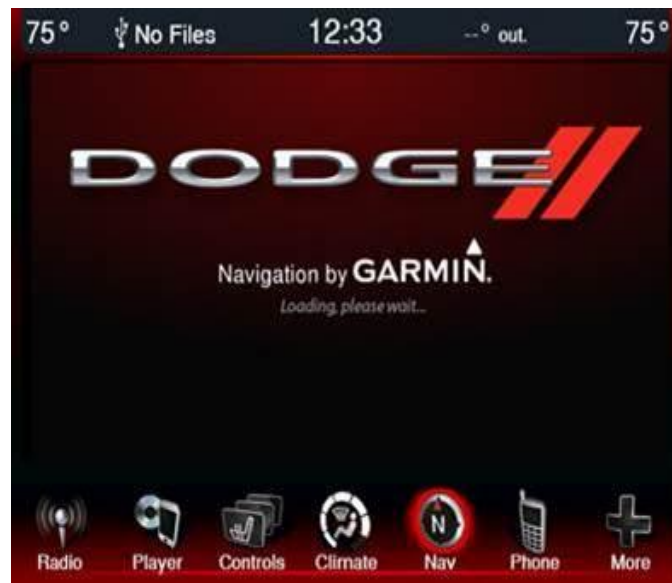
Fig. 1 System Loading Screen

4. Is the radio stuck on the "Loading Please Wait" screen? See ([Fig. 1](#)).
 - a. Yes >>> The radio will have to be replaced. Replace the radio using current electronic exchange center stock following normal warranty repair procedures. Refer to published service information in Tech Connect Section 08 - Electrical/8E - Electronic Control Modules/MODULE, Telematics Gateway/Removal. No further action is required, the bulletin is now complete. The replacement radio will contain the latest software update.

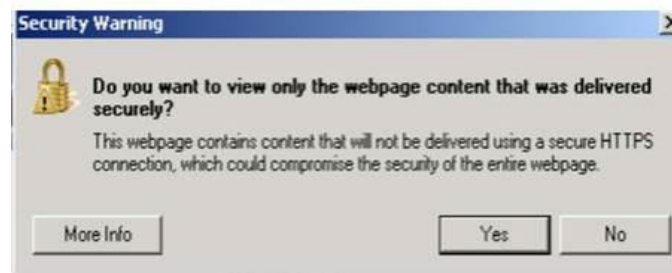
Fig. 2 Pop-up Security Message

5. Has a USB flash drive been created with the current software update?
 - a. Yes>>> Proceed to step [Step #9](#).
 - b. No>>> Proceed to step [Step #6](#).
6. Go to DealerCONNECT>Service>UCONNECT Information & Utilities> Uconnect Dealer software downloads to download the files.
7. If a security message appears "Do you want to view only the webpage content that was delivered securely?" See ([Fig. 2](#)). Press **No** to continue.

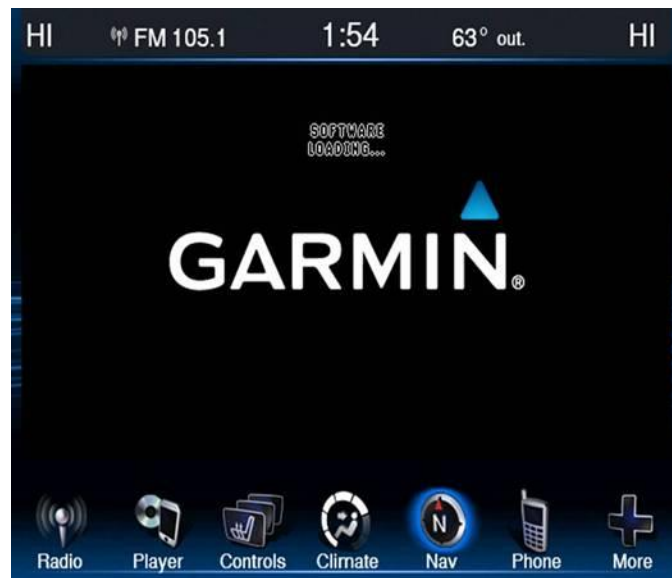
Fig. 8 Garmin Software Loading

CAUTION: Do not interrupt the software update process once it has begun. It may cause permanent damage to the radio which will require replacement.
