# Safety Recall VE2 / NHTSA 19V-886

## Rear View Camera

#### 2018-2019 (RU) Chrysler Pacifica

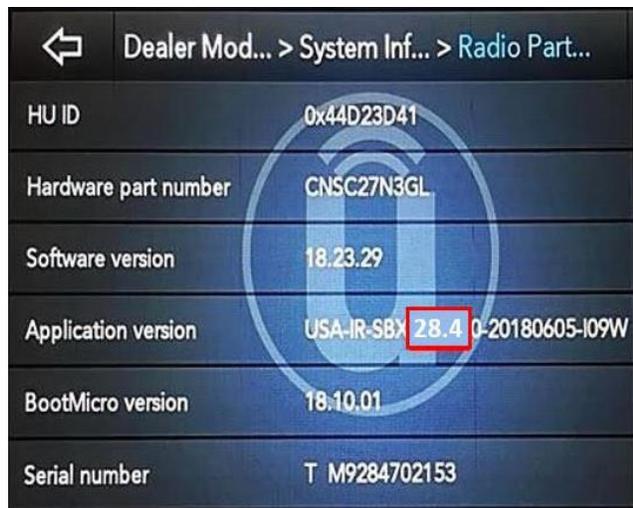
**Figure 1 – Radio Software Level Screen**

b) Select System Information, then Radio Part Information. The software level will be listed next to Application Version (Figure 1).

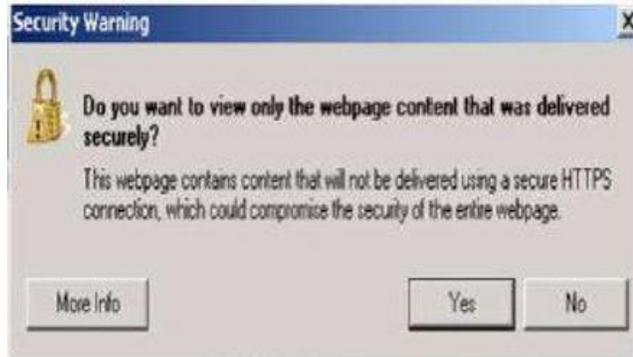
**Figure 2 – Application Version**

5. Go to DealerCONNECT, Service, Uconnect Command Center, Uconnect, More Information, Dealer Software Downloads to download the files.
6. If a security message appears “Do you want to view only the web page content that was delivered securely?” (Figure 2), press “No” to continue.

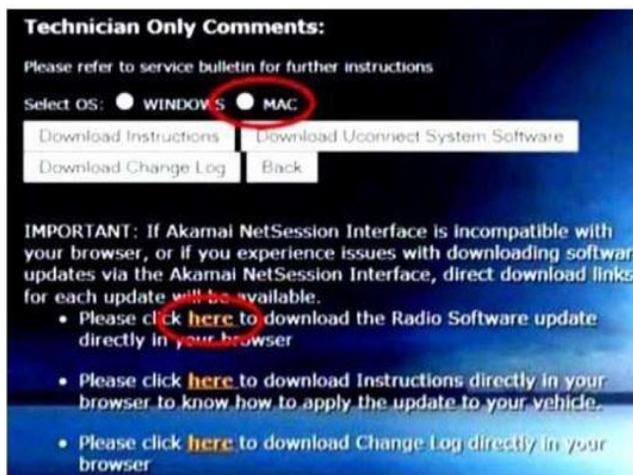
**Figure 3 – MAC Radio Button**

7. Use a blank USB flash drive with at least 16GB of space. Follow the on-screen instructions to download the software files.
8. Download the software update file to your local PC’s desktop. Make sure to select the “MAC” radio button for all downloads, regardless of the computer being used (Figure 3).

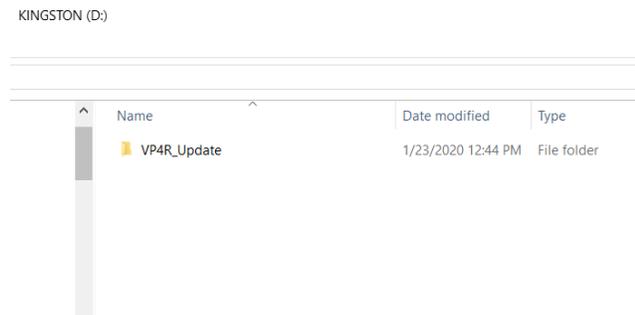
**Figure 4 – Flash Drive Folders**

10. Extract the compressed folder to the desktop. Open the folder and drag and drop the VP4R\_Update files to the USB flash drive. The flash drive should look like (Figure 4).

*NOTE: Revised Step 2 for easier access to dealer mode. Updated Note to clarify USB usage. Revised step 10 and Figure 4 to show new file structure based on updated software. Revised LOP numbers to reflect updated software.*

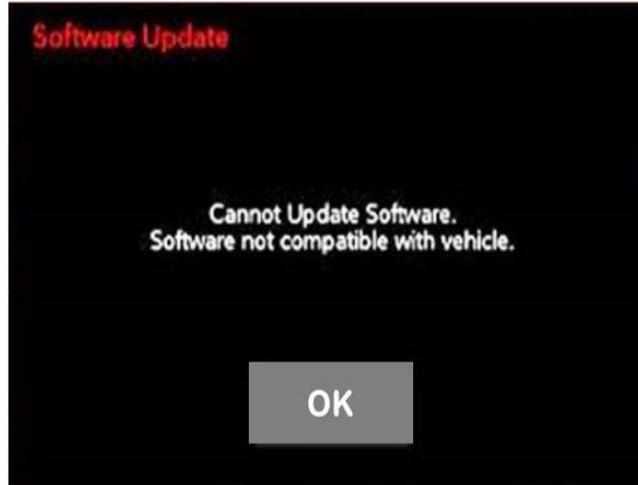
Figure 5 – Software Not Compatible

- 13. If the screen in (Figure 5) is displayed, the USB flash drive was not set up correctly. Use a top name brand USB flash drive like Kingston and create a new flash drive and start the update again.

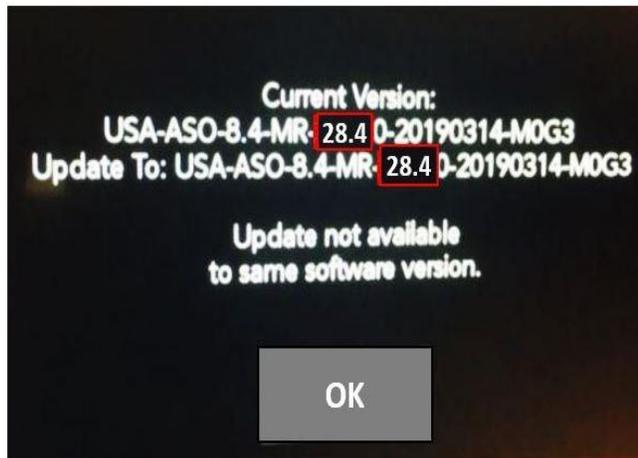
Figure 6 – Radio Software Already Up To Date

- 14. If the radio software is up to date, the screen in Figure 6 will be displayed. Press "OK" and remove the USB flash drive (Figure 6).

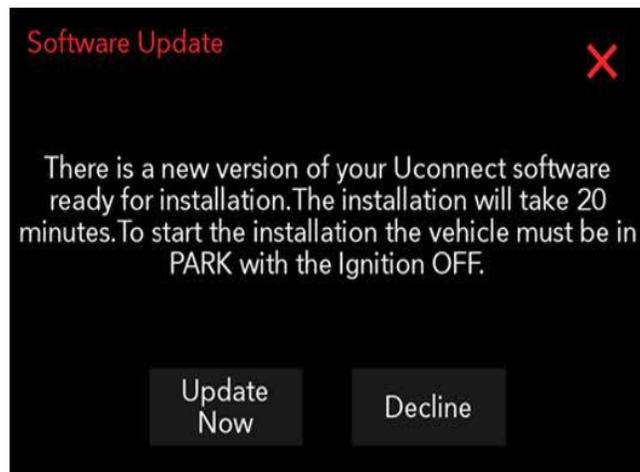
**Figure 7 – Software Update Is Available**

15. Once the system has verified there is an available update, press the “Update Now” button. Make sure the vehicle is in park. Do NOT turn off the ignition at this point (Figure 7).

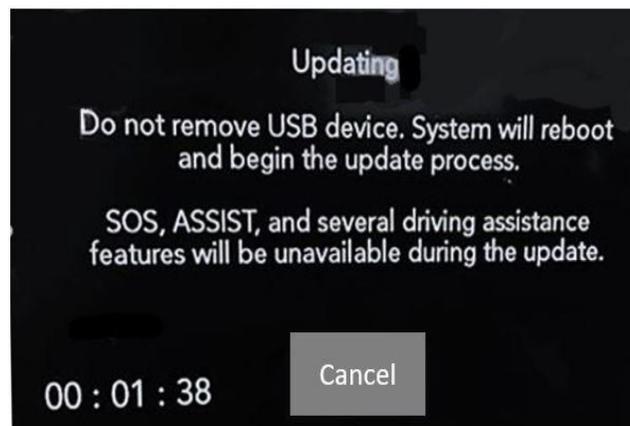
**Figure 8 – Radio Update Process Begins**

16. When the radio starts updating, this screen will be displayed (Figure 8).

**NOTE:** If the ignition is turned off before the two minute has expired, the software update will be canceled. The ignition does not have to be turned off to perform this updated (Figure 8).
